Livett 1889 G. M. Livett, 'Foundations of the Saxon cathedral church at Rochester', *Archaeologia Cantiana*, 18 (1889), 261--78.

FOUNDATIONS OF THE SAXON CATHEDRAL  
CHURCH AT ROCHESTER.

BY THE REV. GREVILLE M. LIVETT,  
MINOR CANON AND PRECENTOR.

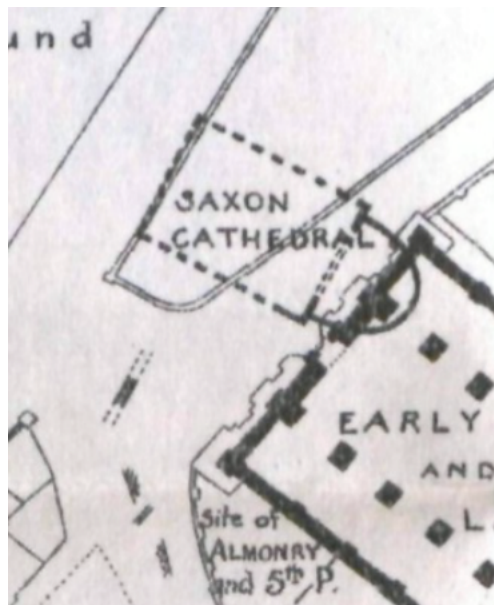
which Mr. Livett has obligingly communicated to me. From the combined data it appears that this church consisted of an aisleless nave, in round numbers 42 feet long and 28 feet wide, with an eastern apse 24½ feet wide and 19 feet long. If there was a western apse/‡ or porch, the foundations of it lie under the street, and could not be looked for. ...

I am glad to have this early opportunity of describing the complete plan of Æthelbert's first cathedral Church, built in 604 and partly discovered in 1889 (*Arch. Cant.*, Vol. XVIII.). The north-east corner of the nave was disclosed in the summer of 1894, when a trench was dug, for the purpose of lowering the gas main, along the middle of the road that runs by the west front. At the same time the lines of the foundations of the nave walls were followed westwards, in the burial-ground, by means of a probe. The

nave seems to have measured, in round figures, 42 feet by 28 feet. The foundations of the west wall seemed to line very nearly with the west side of the burial-ground. No signs of aisles, quasi-transepts, or porch were revealed. If a porch existed at the west end of the Church its foundations must be under the road and could only be discovered by excavation. ...
